ANALYTICAL INVESTIGATION OF TRADITIONAL LIME PLASTERS. THE CASE OF SARDINIA (ITALY)

Enrico Fodde (MA, PhD)

Abstract

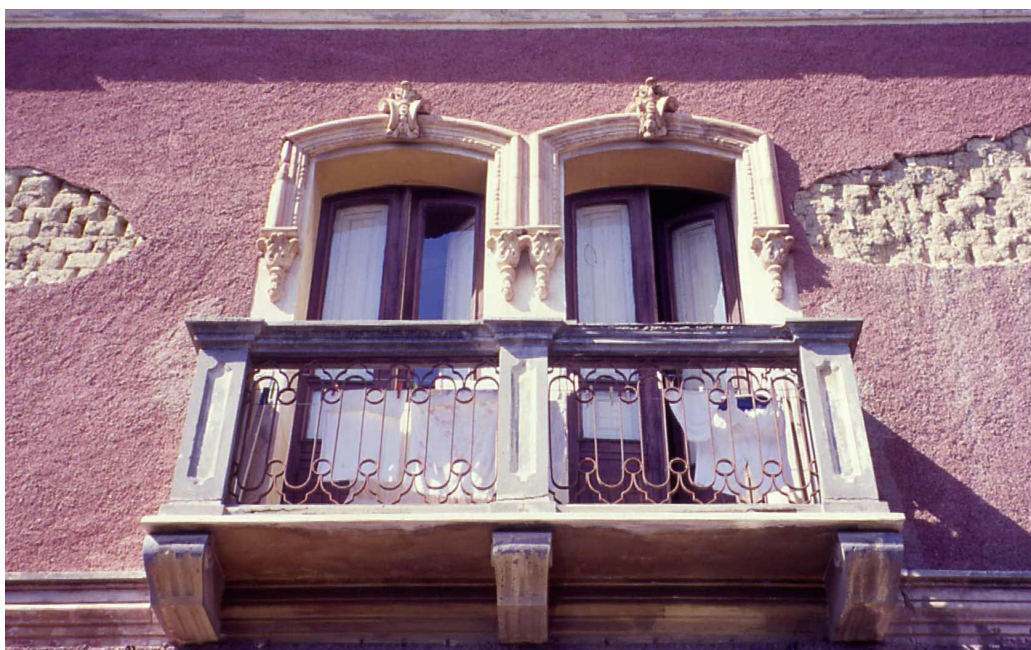
Fig. 1. An earthen building of Campidano showing lime render on mud brick masonry

(village of Monserrato).

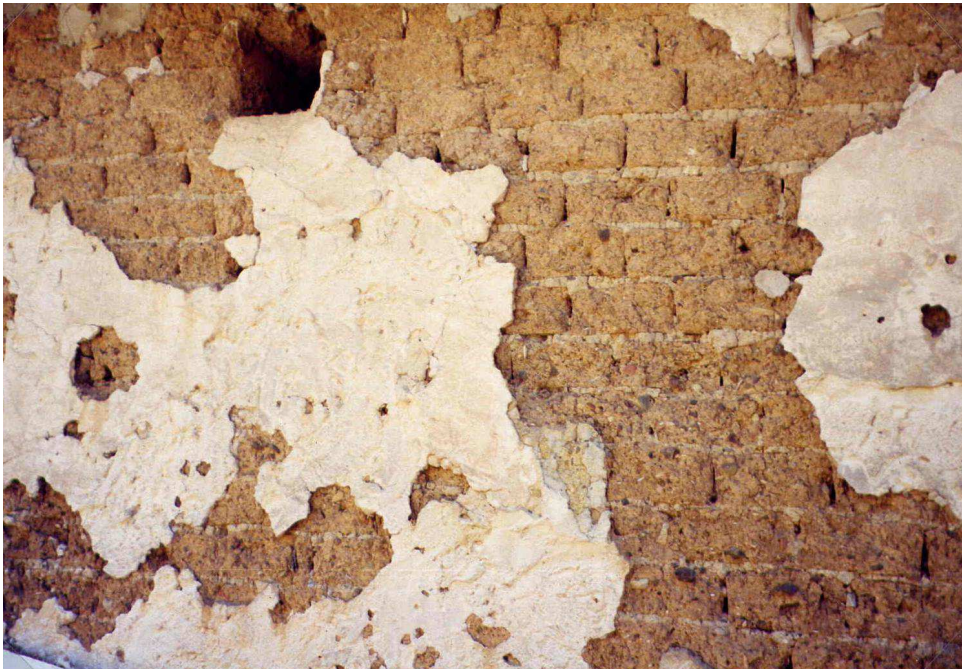
Fig. 2. Sampling of lime render was done to cause minimum destruction, and mostly in building with high decay levels such as this one in the village of Sinnai.

Five samples were considered to be the minimum representative for the sub-groups. Selecting sets of four of such samples (interior skim, interior scratch, exterior scratch, and exterior skim) from one single building was often found to be impractical¹. Convincing owners to allow the sampling of their interior renders was also a complicated task. The author also found that detecting ideal buildings with both interior and exterior renders made of lime as a binder was a complicated task because hybrid types with inclusions of mud are quite common in Campidano. Furthermore, it is common to find interior and exterior lime renders made of single coats only. As a consequence of this, independent samples were collected. Unoccupied buildings were by and large the easiest target for sampling interior renders, as it would have been otherwise difficult to convince the occupiers to permit the taking of specimens from the inside of their dwellings. Collection was always tackled at a height of 1.2 metres from ground level.

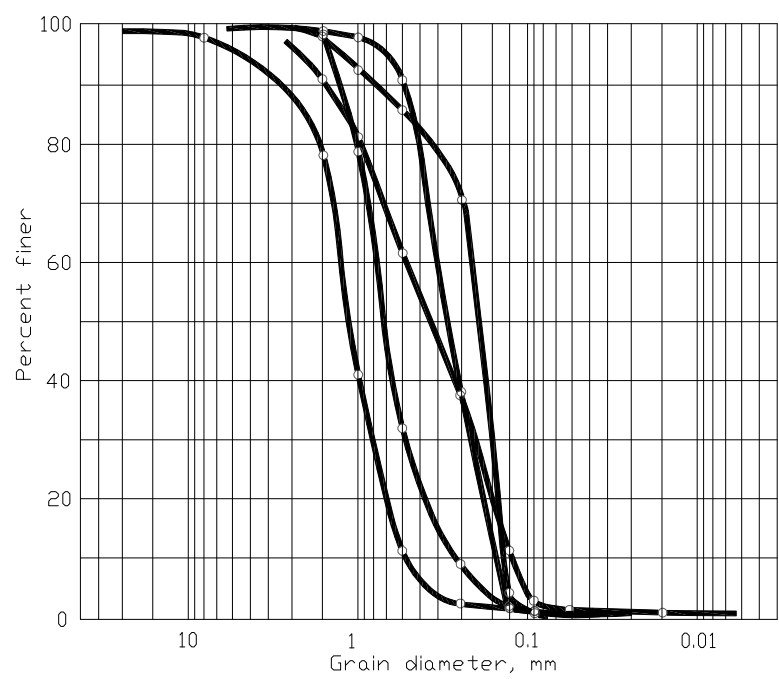
Fig. 3. Grouping of granulometry curves (interior scratch coats)

An effective methodology for the study of the grain size distribution curves of a population of samples is provided by Fadli (1995, 29-32) and is adopted here in this study. It consists in the grouping of all curves in order to create an S-shaped area (Fig 4). The two curves deriving from the perimeter of the area are defined by Fadli (1995, 29) as: *minimum curve*, or the entirety of the recorded minimum values; and *maximum curve*, or the entirety of the recorded maximum values (Fig. 4). The average of the entirety of values is defined as the *ideal curve*. The area under consideration, being asymmetric, can be corrected in order to allow the same of variation from both sides of the ideal curve. Another area, called *theoretical area*, as the zone with a high concentration of curves (Fig. 5), of which the average curve is the ideal one. The representation of the theoretical area was undertaken after calculating the following divergence values for every grain diameter:

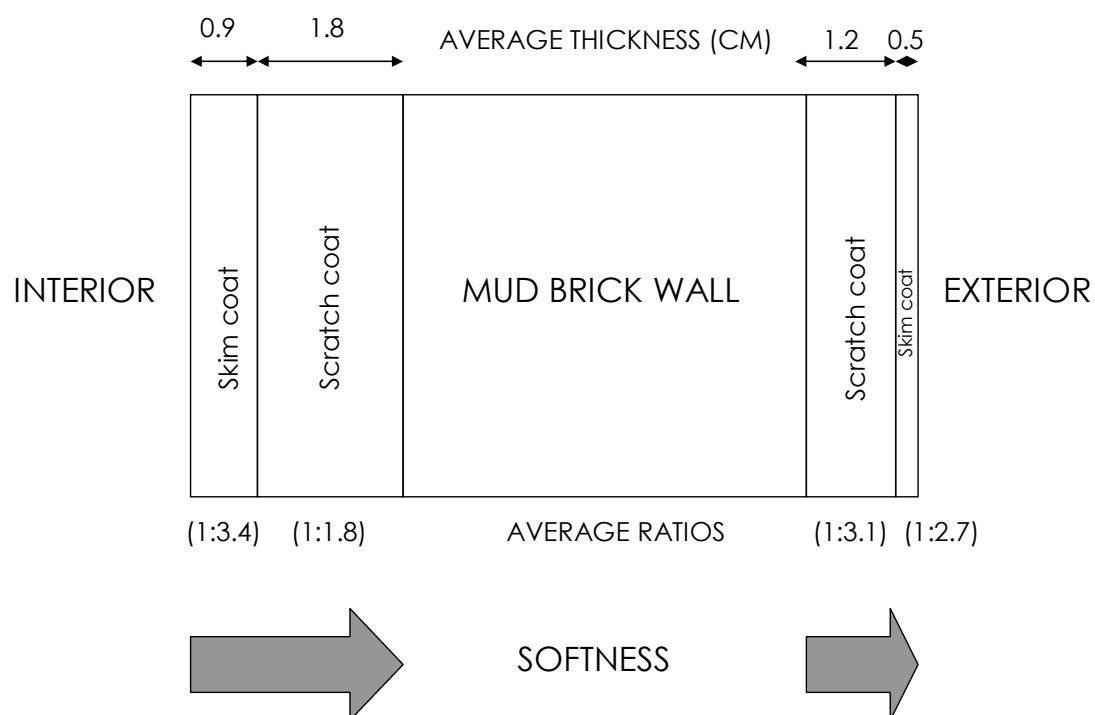
Fig. 10. Drawing showing increase in softness of coats from inside to outside

The percent of impurities is such that the lime can be classified as non-hydraulic, fat, pure or with high calcium. This type of lime is characterised by a very fast slaking time, considerable expansion, and by a white colour. The dissolution of renders in hydrochloric acid shows that the skim and scratch coats of both internal and external surfaces have variable lime:aggregate ratio which is a function of the type of coat. The experimental analysis therefore confirms that the typical 1:3 ratio is not standard in Campidano. The reason for this finding is that external and internal coats are designed to form a porous system. Internal coats are characterised by increasing softness from the limewash to the scratch coat, whilst external coats show increasing softness from

the scratch coat to the limewash. It is proposed here that this porous system allows both the condensation present in the internal wall surface and the moisture present in the mud brick to be driven outside the building. Other useful findings are represented by the recommended zones for the granulometry curves of the aggregates of skim and scratch coats of both interior and exterior renders. Furthermore, the presence of impurities in the aggregate demonstrates that the traditional craftsmen were correct: river sand was commonly employed and was rarely washed of all impurities before use. To summarise, the main findings of these tests were:
